# PERFORMANCE TEST

# **PARTITION WALL SYSTEM**

# UCO SolidPanel System of 75mm THK

BS 5234: Part 2: 1992 or SS 492: 2001

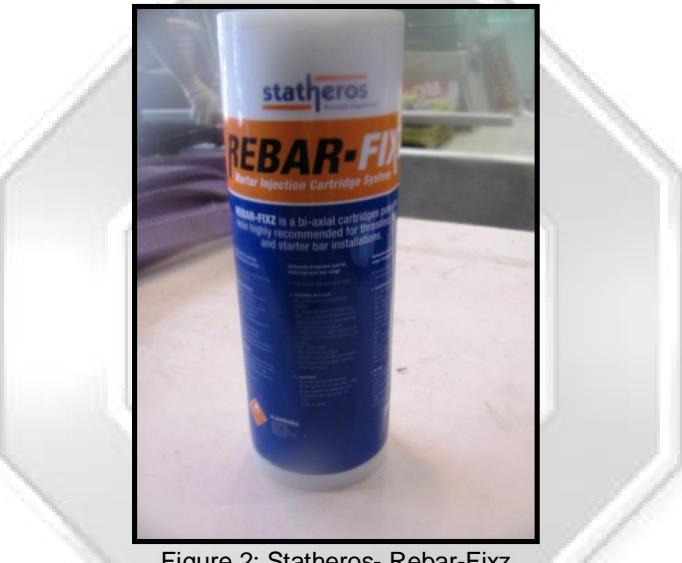
Figure 2: Statheros- Rebar-Fixz

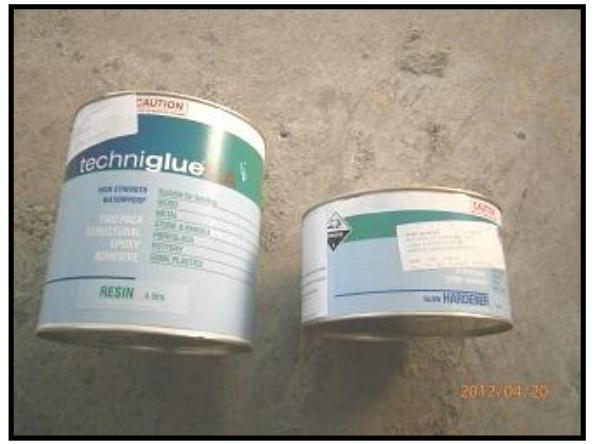
Chemical used for additional tests- Techniglue (consist of resin and harderner mixture, the mix ratio is resin 2 and harderner 1)

Figure 1: Techniglue

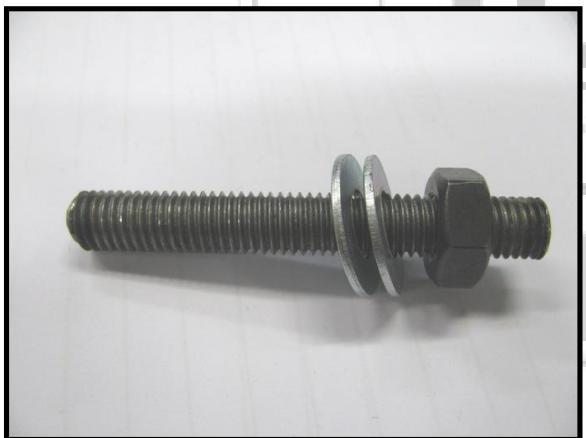
Figure 4: 10mm screw with statheros – rebar fixz for heavy anchorage test(wall cupboard and wash basin)

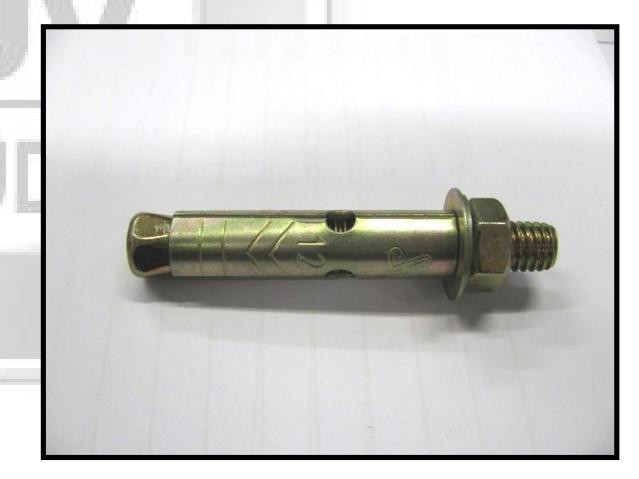
Figure 5: 12mm wallplug with techiglue for heavy anchorage test (wash basin)

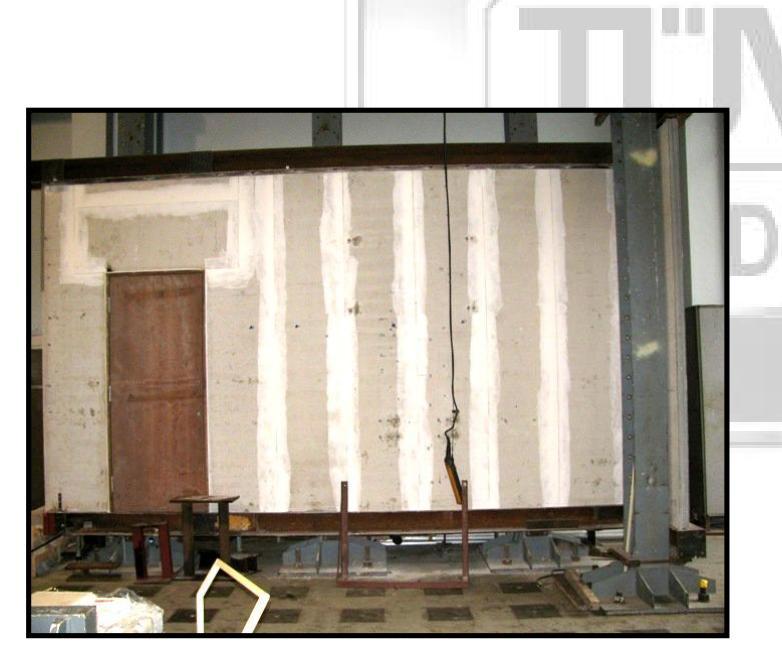
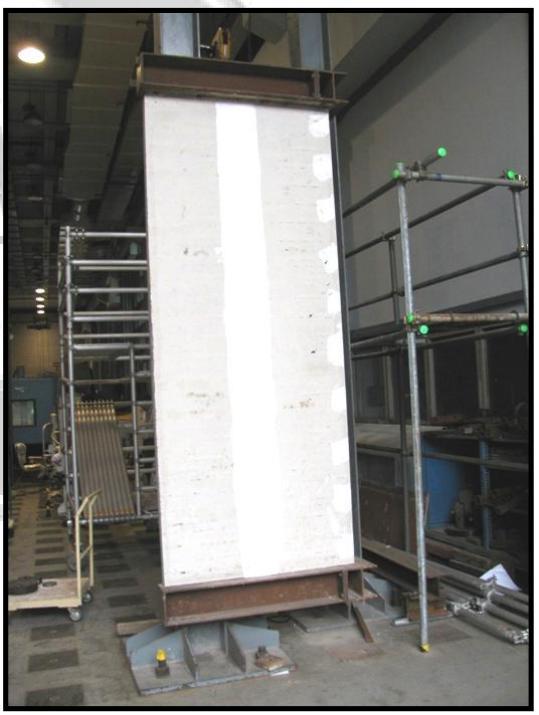
A mock-up test specimen 6 m (L) X 3 m (H) and a partition junction assembly of a right-angle corner with a return of 1.2 m (L) was installed onto the test rig for the performance test. Total, 5 sheets of company's drawings contain the details of the mock-up specimen.

The test specimen includes a doorset 0.9 m width X 2.1 m height and a 0.60 m run of partition flanking at one side of the doorset.

Figure 6: Test specimen mock-up

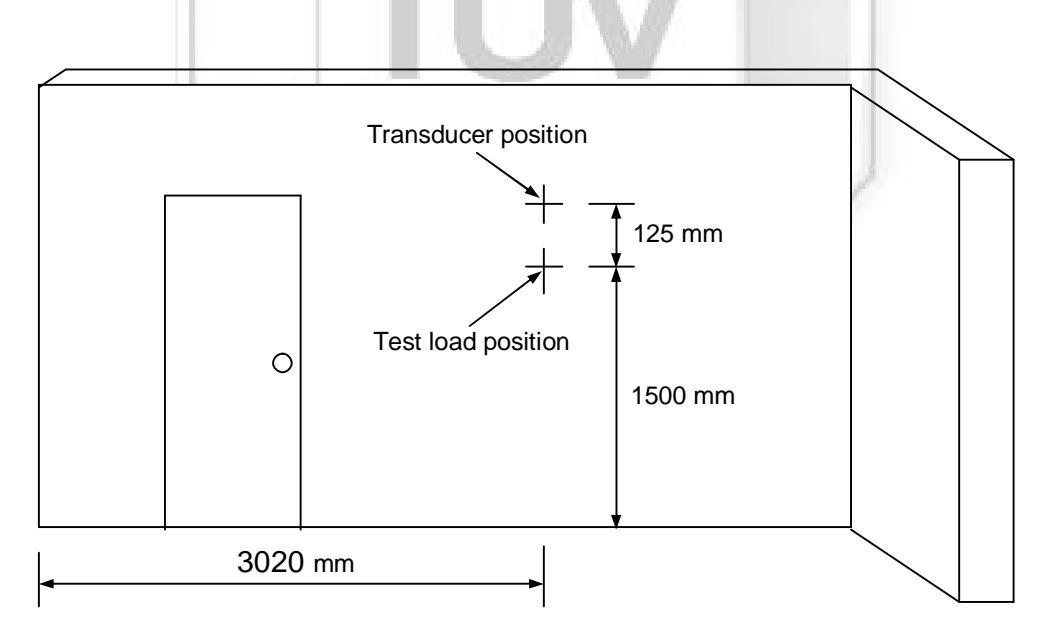
Load (N)	Duration (min)	Deflection (mm)	Residual Defection (mm)	Condition of the specimen tested	BS 5234: Pt 2: 1992 or SS 492: 2001 Requirements
Pretest load of 100 N	1	-//			1) There shall be no damage or detachment, loosening or dislodgement of partition wall's
100	2	0.17	-	Passed (No damage occurred)	parts or fixing
200	2	0.33			
300	2	0.52	1/-		2) The Maximum deflection
400	2	0.75	-		and residual deformation shall
500	2	1.01	0.01		respectively.

A static horizontal load of 500 N ( $\pm$ 15 N) was applied through a 150 mm ( $\pm$ 1 mm) diameter steel plate with a contact rubber pad of 6 mm ( $\pm$ 2 mm) thick. The load was applied to the partition at a height of 1500 mm ( $\pm$ 10 mm) from the bottom of the setup. Deflection was taken on the load side at 125 mm above the centre point of load application. A pretest load of 100 N was applied and stabilised for 1 min before unloading. The load was then applied in steps of 100 N until 500 N before unloading. Each loading was maintained for about 2 minutes for stabilisation.

Deflection was taken at the end of the 2 minutes interval. The residual deflection was taken when it had fully stabilized or 1 hour after unloading whichever occurs first.

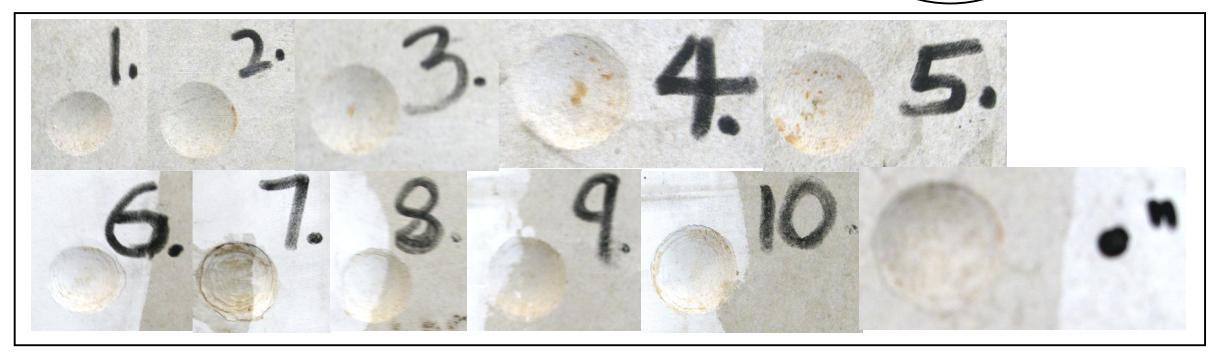
Impact	Y X		Depth of indentation Condition of the	Condition of the	BS 5234: Pt 2: 1992
Position	(mm) (	(mm)	(mm)	specimen tested	or SS 492: 2001
1	270	、 ,	2.04	•	Requirements
	3/0		2.94		
2	1030	2065	2.50		
3	1570	3005	2.57		There shall be no perforation
5	1600		2.37		of the partition wall, corner junction, or panel of a hollow
6	215		3 29	Decod	
7	525		3.98	rasseu	partition wall, after being
8	870	3405	3.48		subjected to the impact
9	1115	5405	3.60		energies.
10	1/25	11	3.58		
**11	1700	75	4 26		
**Note: Co	prner jun	ction	4.20		
				View A	
Y A B C C C C C C C C C C C C C

Figure 11: Perforation by small hard body impact - closed up view of indentations

10 positions on the main wall of the test setup were chosen for the test. Each position was subject to a 30 Nm impact energy. The swinging arm was raised by 1.0 m or 131.8 degree and released. The rebounce of the steel arm was withheld to prevent it from making a second impact. The partition was inspected for any damage or perforation.

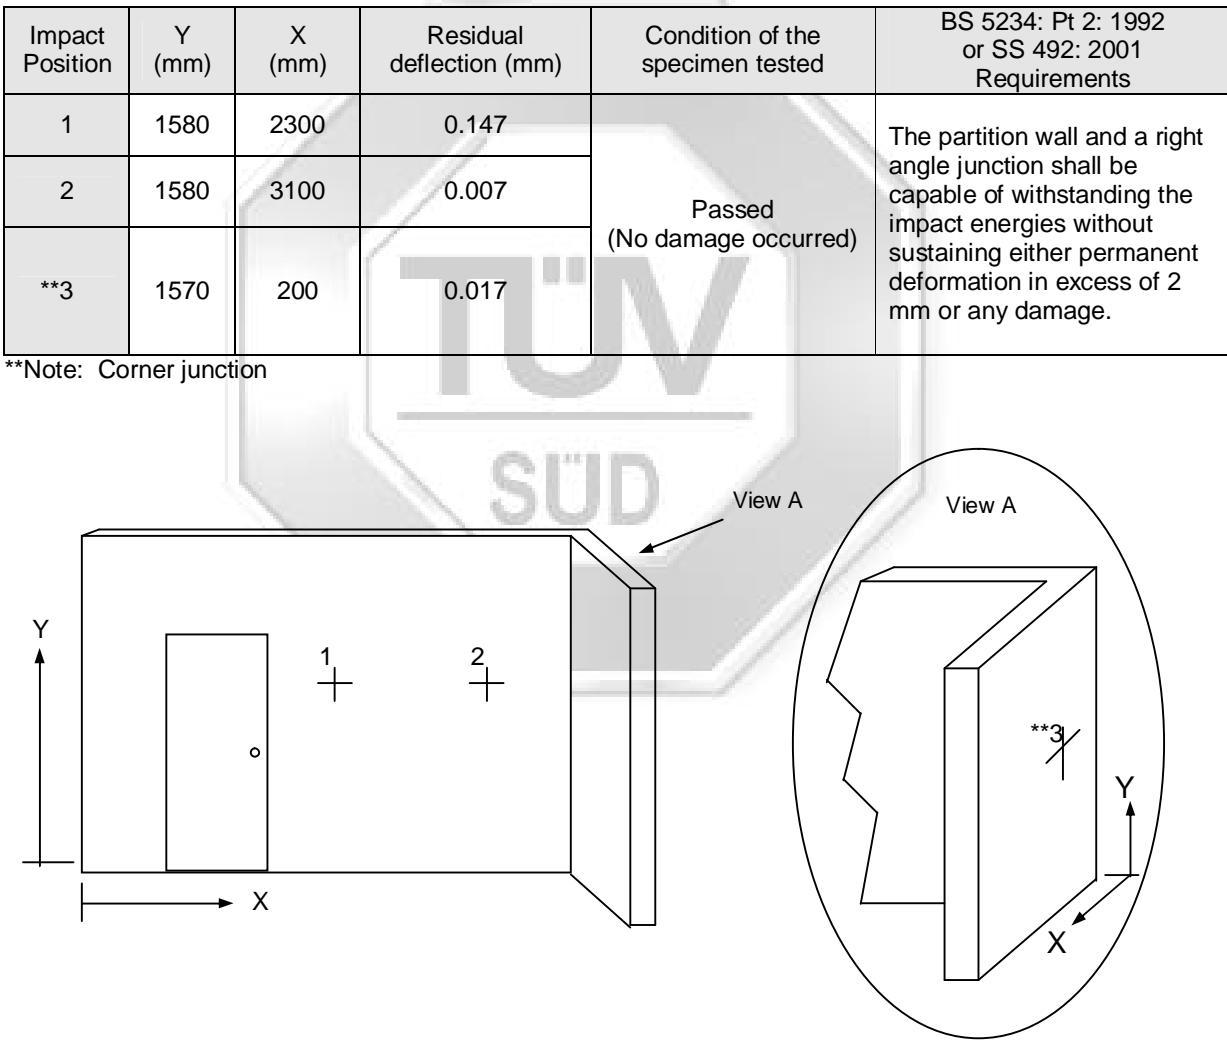
Figure 12: Locations of large soft body impact for resistance to damage

Two positions on the parititon wall were selected for the test. Each location was subject to a single swinging impact. A linear gauge was placed behind the impacted panel to measure the permanent deformation.

The impact energy was 100 Nm. The impactor was raised by 204 mm before releasing. Permanent deformation was taken after 5 minutes from the impact.

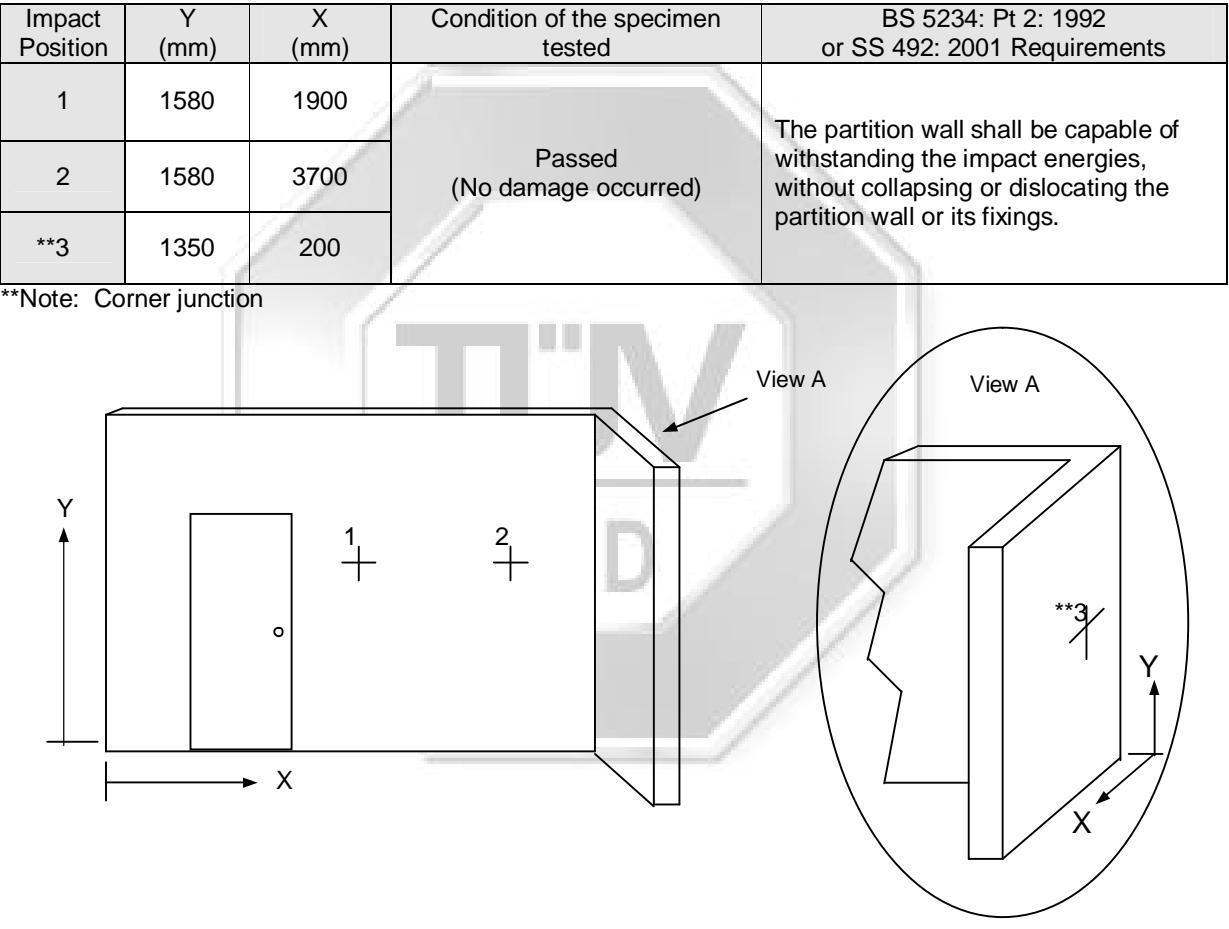
Figure 13: Locations of large soft body impact for resistance to structural damage

Two positions on the partition wall were selected for the test. Each location was subject to three swinging impacts.

The impact energy was 120 Nm. The impactor was raised by 245 mm before releasing. The partition was inspected for any surface or structural damage.

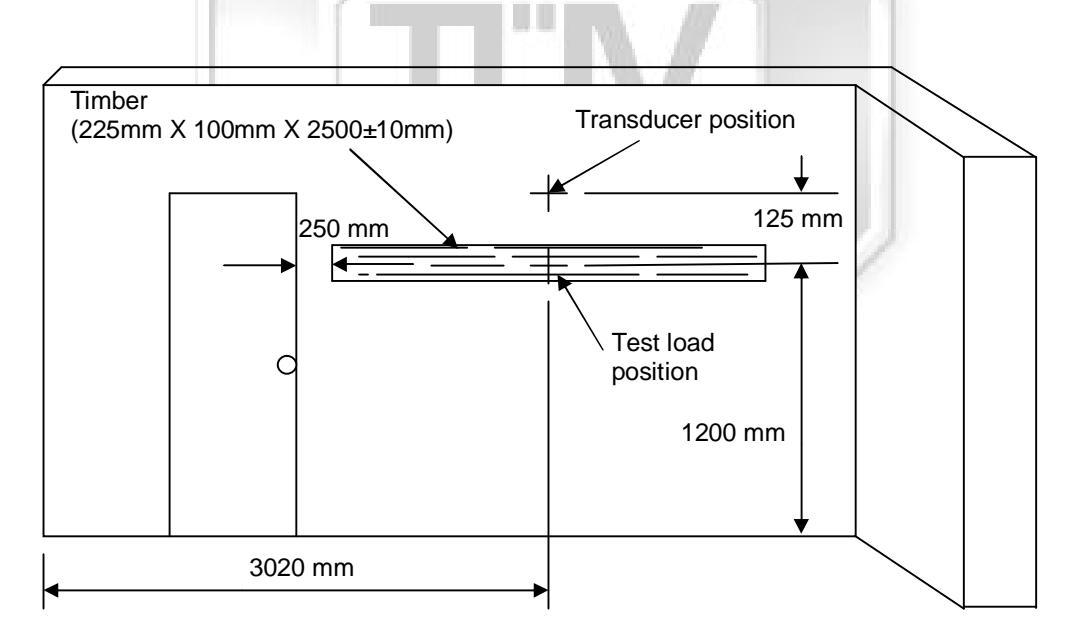
Load	Duration (min)	Deflection (mm)	Residual Deflection (mm)	Condition of the specimen tested	BS 5234: Pt 2: 1992 or SS 492: 2001 Requirements	
Pretest load of 200 (N)	1	0.4	0.05		There shall be no collapse or damage that would	
3.0 kN/m	2	13.30	5.44	Passed (No damage occurred)	render the partition wall dangerous, due to any of its parts becoming dislodged or shattered, in a manner that could cause injury.

Figure 14: Locations of applied load for crowd pressure

A test load of 3.0 kN/m was applied through a 2.5 m long wooden beam placed at a height of 1.2 m above the bottom of the wall. Deflection was taken at 125 mm above the beam. Residual deflection was taken after 5 minutes upon released of the load.

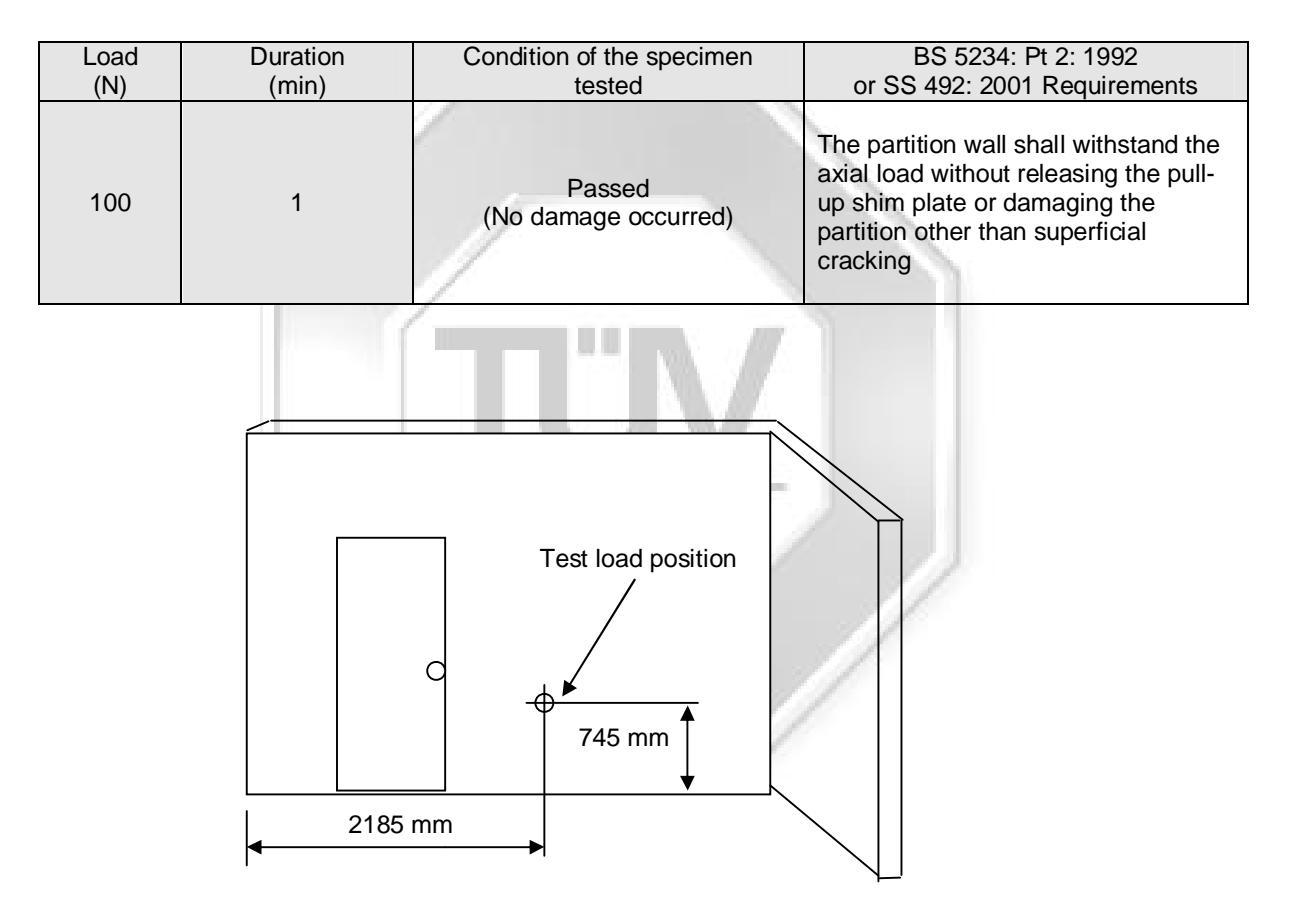
Figure 15: Locations of applied load for lightweight anchorage Pull-out test

A pull out load of 100 N (±3 N) perpendicular to the wall was applied on the bracket. The load was held for 1 minute before releasing.

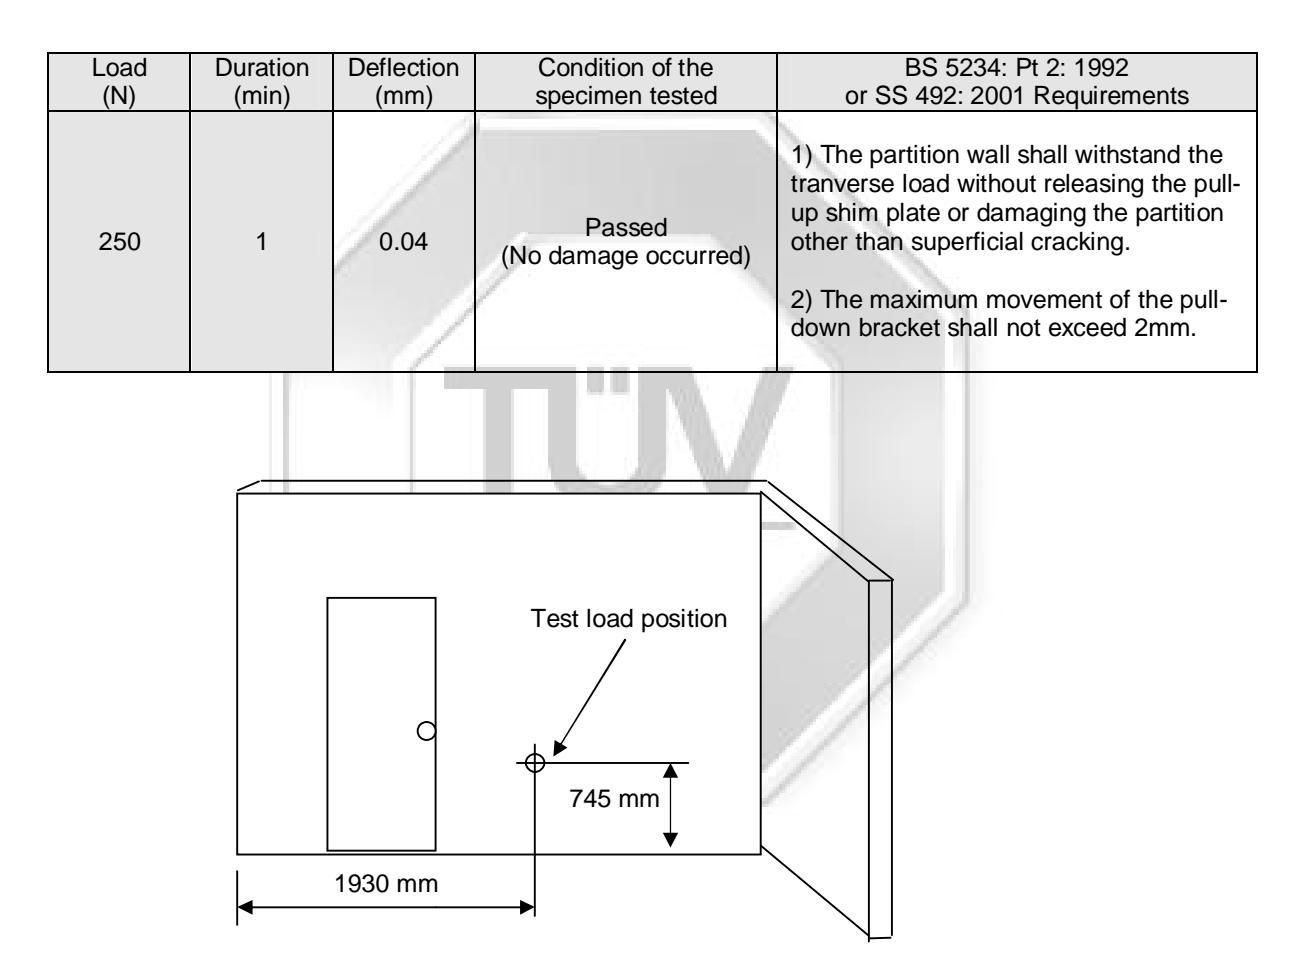
Figure 16: Locations of applied load for lightweight anchorage Pull-down test

A pull down load of 250 N (±7.5 N)parallel to the wall was applied on the bracket. The load was held for 1 minute before releasing.

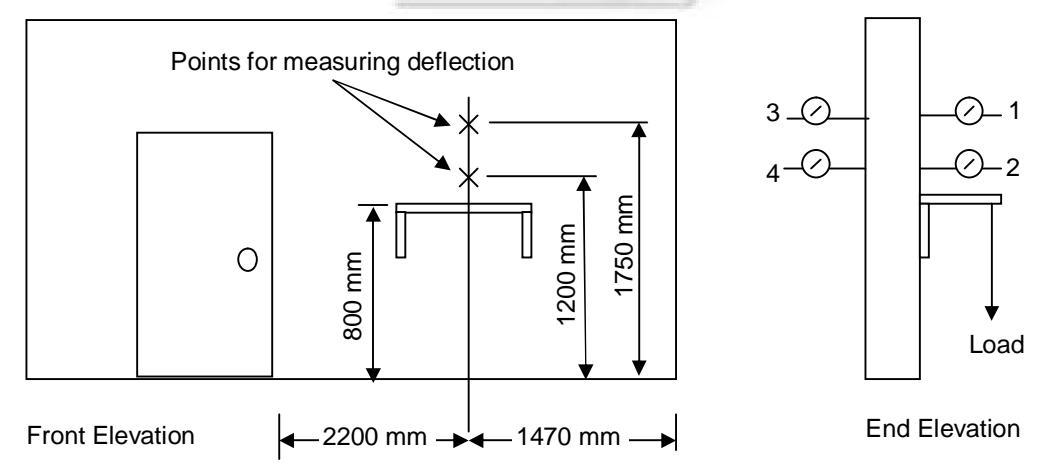
### 6.7.1.1 Heavy weight anchorage Wash basin with 10mm Screw (Rebar-fixz)

Note : All fasteners for attaching the brackets to the partition wall were secured to the studs.

A steel bracket identical to a standard wash basin was mounted at a height of 0.8 m ( $\pm$ 10 mm). Four deflections were taken, two on each side of the wall, at a height of 1.2 m and 1.75 m from the base of the wall. Shim plates were inserted in between the bracket and wall and loaded with a force of 20 N.

Cyclic load of the following sequence was applied: 500, 750, 500,750, 500,1000, 500, 1000, 500, 1250, 500, 1250, 500, 1500, 500, 1500 & 500 N. Residual deflections were taken after 5 minutes from unloading.

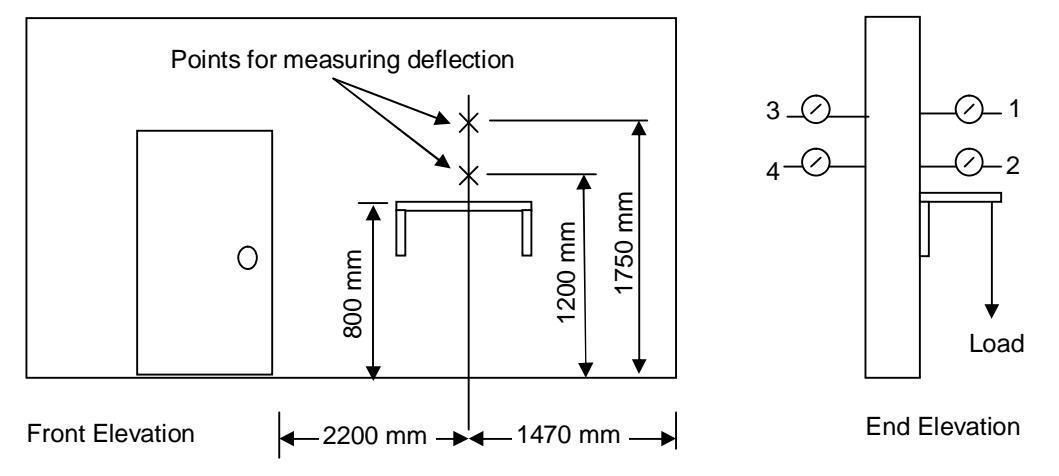
Figure 18: Locations of applied load for heavyweight anchorage (Wash basin) eccentric downward loading test test

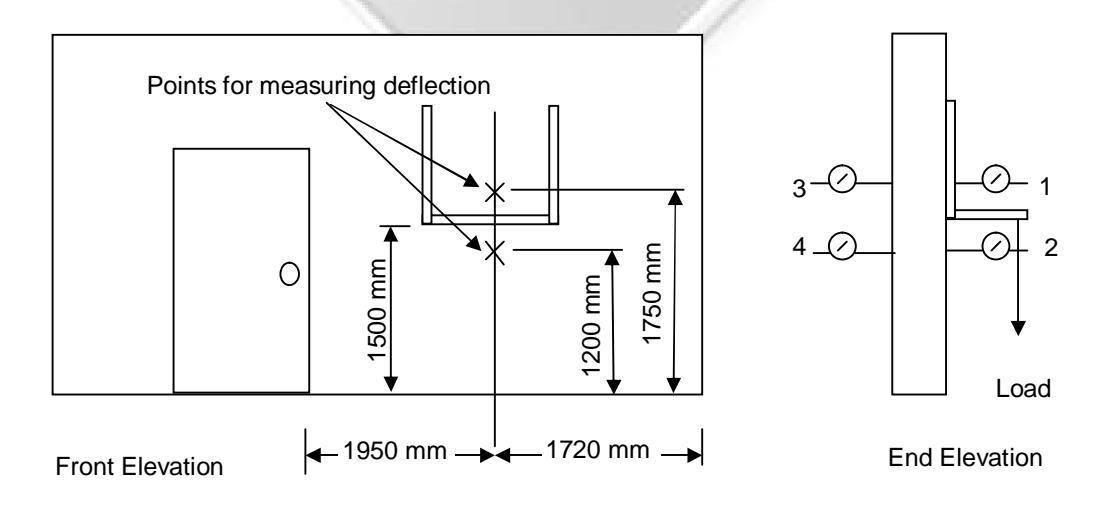
Figure 19: Locations of applied load for heavyweight anchorage (High level wall cupboard) eccentric downward loading test

A steel bracket identical to a standard wall cupboard was mounted at a height of 1.5 m ( $\pm$ 10 mm). Four deflections were taken, two on each side of the wall, at a height of 1.2 m and 1.75 m from the base of the wall. Shim plates were inserted in between the bracket and wall and loaded with a force of 20 N ( $\pm$ 1 N).

Incremental load of the following sequence was applied: 500, 1000, 1500, 2000, 2500, 3000, 3500, 4000 N. Residual deflections were taken after 5 minutes from unloading.

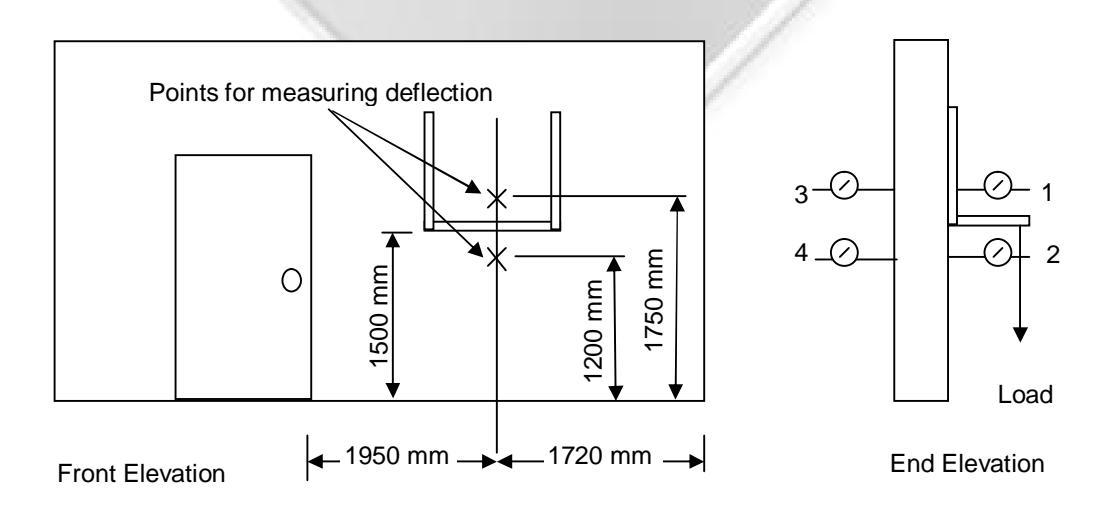
Figure 20: Locations of applied load for heavyweight anchorage (High level wall cupboard) eccentric downward loading test

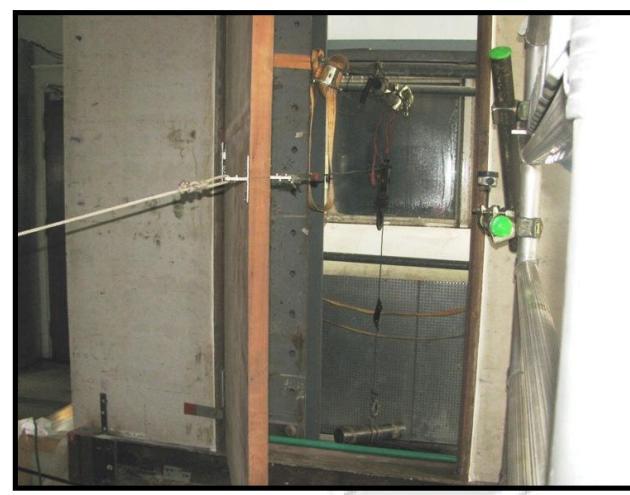
Figure 21: Door slam

A 60 kg ( $\pm$ 0.5 kg) door leaf was slammed through an opening angle of 60 degrees ( $\pm$ 1 degree) with a force of 15 kg ( $\pm$ 50 g) for 100 times. Residual deflection was taken on the door frame at 1 m above the bottom of the door leaf after 5 minutes from the last slamming.

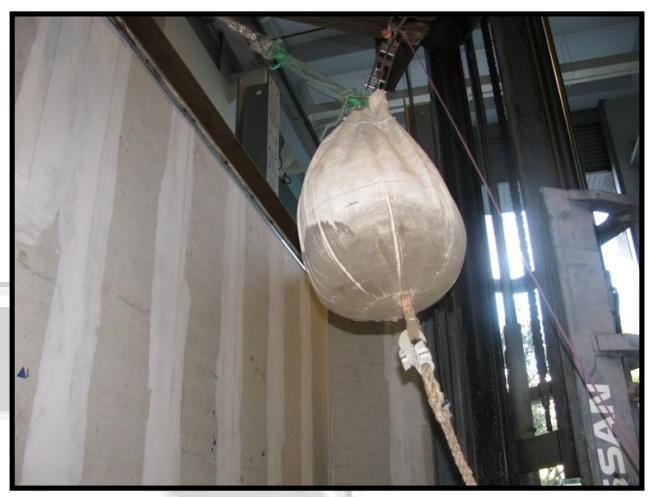
Figure 22: Large soft body impact (resistance to damage / structural damage)

The test is to simulate impact caused by people falling against or any large soft body object such as a ball hitting the partition wall. The impactor is a spheroconical bag of 600 mm X 400 mm filled with hardened glass beads. It has a total weight of 50 kg ( $\pm$ 5 kg).

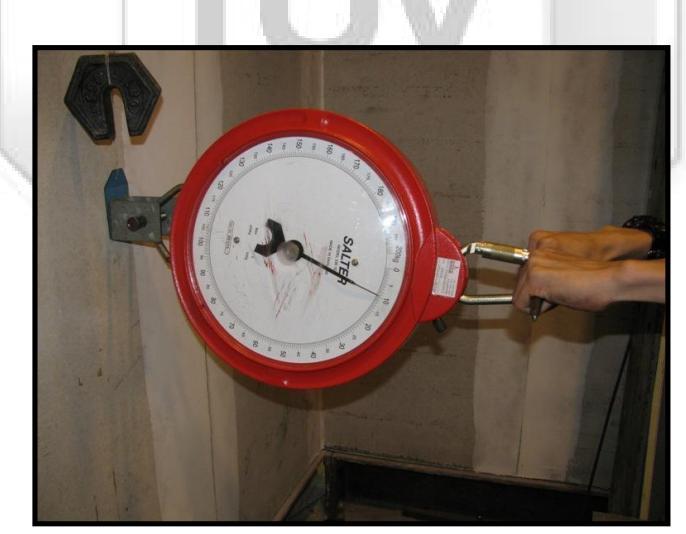
Figure 23: Lightweight anchorage- pull-out test

The test determines whether the partition wall can withstand light weight fixtures such as those for wall picture, clothing hook and basic wall shelving. A U-shaped steel bracket was secured by the specified anchorage. A shim plate was placed in between the steel bracket and the wall. A load of 20 N ( $\pm$ 1 N) was applied on the shim plate.

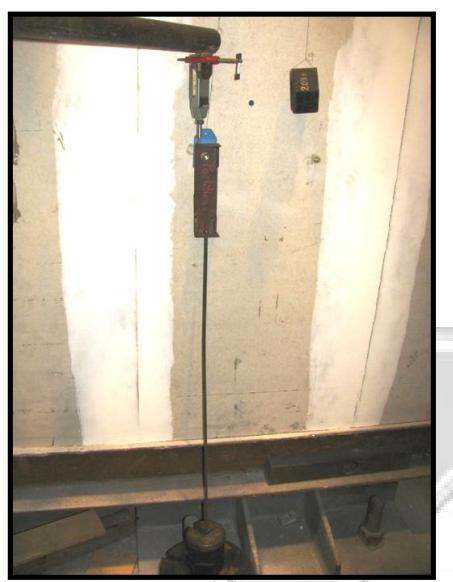
Figure 24: Lightweight anchoragepull-down test

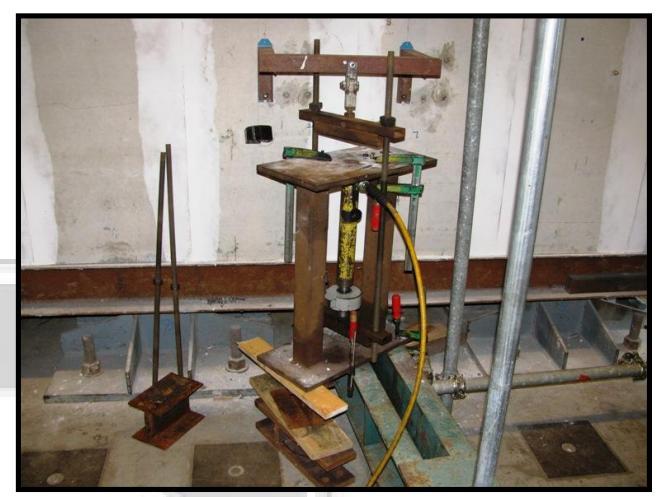
Figure 25: Heavy weight anchorage- wash basin

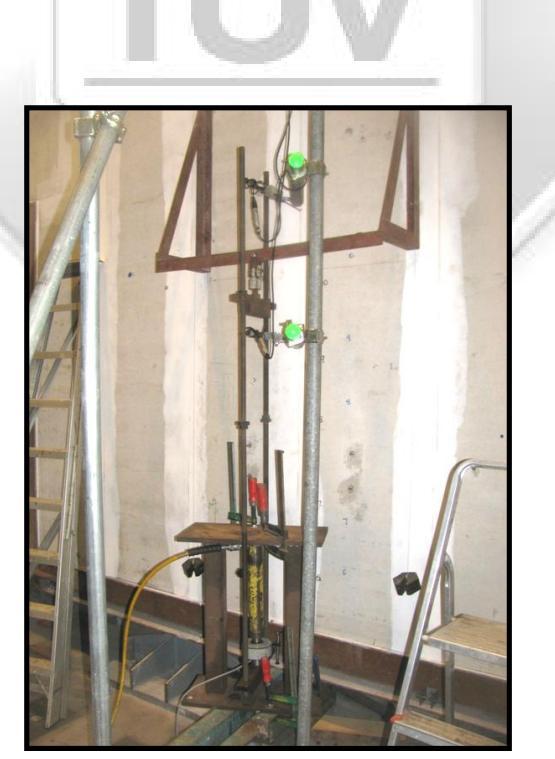
Figure 26: Heavy weight anchorage- wall cupboard
